Overtopping Performance of Earthen Dams during Record Flooding in Columbia, South Carolina

B. Crookston¹ and T. E. Hepler²

¹ Senior Engineer, Schnabel Engineering LLC
West Chester, PA 19382
USA

ABSTRACT

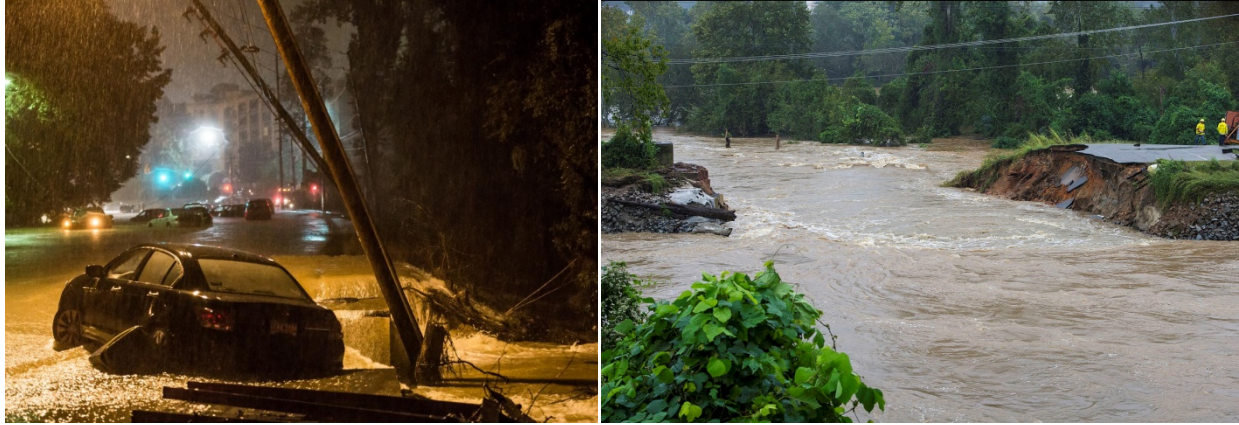
An estimated 4.4 trillion gallons of water fell on South Carolina. As a result, thousands of residents left their homes to escape life-threatening floods. Over 410 local roads and bridges were closed, including over 70 miles of Interstate 95. About 2,000 auto collisions occurred across the state because of the storm. More than 200 water rescues were performed and over 1,100 South Carolina National Guard members were activated. Drinking and wastewater systems were badly damaged and more than 50,000 residents were without power (see Figure 4a). The South Carolina Department of Health and Environmental Control (DHEC) issued emergency orders on 75 dams in the state, with the vast majority of them privately-owned earthen dams (www.scdhec.gov). State-wide, 36 dams failed – 31 state-regulated, 1 federally-regulated (on Fort Jackson), and 4 unregulated (see Figure 4b). Sixteen dams failed in Richland County alone and several more were in danger of failing. Eleven of these dams showed repeated deficiencies in previous dam safety inspections (including inadequate spillway capacity and heavy vegetation on the embankment), which had not yet been addressed. Most tragic of all were the 19 flood-related deaths (11 due to drowning), including a first responder whose work truck was swept away by the flood, and a report of several motorists trapped below failing dams that were also eventually swept away. Agricultural losses of \$376 million were estimated by the South Carolina Department of Agriculture. Total economic losses were estimated by insurance broker Aon plc to be about \$2 billion.

Figure 4. Flooding in the City of Columbia (A) (photo by Sean Rayford) and at the Columbia Riverfront Canal (B) (photo by South Carolina National Guard)

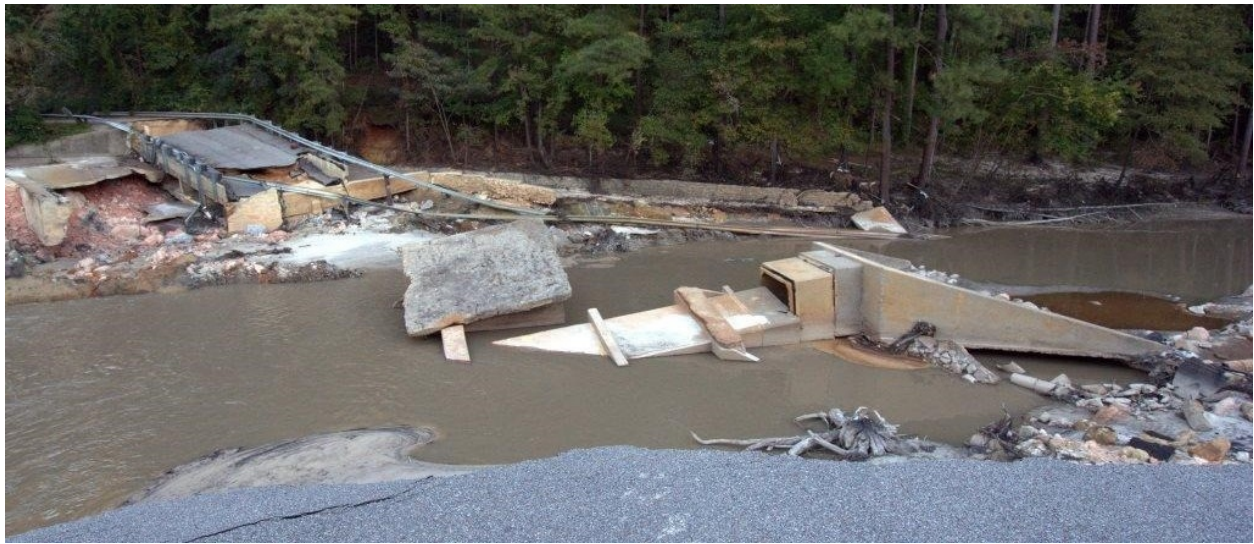
This high-hazard dam was completely breached to streambed on Sunday morning, October 4, during an estimated 4 feet of overtopping (see Figure 5). Only one upstream, unregulated dam (Pine Tree Lake Dam) failed during the flood, but it is estimated that this failure occurred several hours after the overtopping and breach of Cary's Lake Dam (unconfirmed). The breach of Cary's Lake Dam nearly extended to the concrete spillways on both abutments, and measured 137 feet at the dam crest and 70 feet at the dam foundation for the 20-foot depth. Representative samples of the failed embankment soils were classified as a poorly-graded sand with silt (SP-SM) (Tabrizi, 2016). Under the current breached conditions, the overall concern for this site for future flood events is considered to be low (HDR, 2016). Privately-owned by an association of 46 homeowners, this dam was among those regulated by DHEC, and the public roadway on the crest was state-maintained. Preliminary repair estimates approach \$1.5 million, with as yet undetermined potential funding sources.

Figure 5. Full breach of Cary's Lake Dam embankment at maximum section and low-level outlet (photo courtesy Schnabel Engineering).

Heritage Engineering is developing preliminary designs to reconstruct Cary's Lake Dam and to repair Spring Lake Dam. Due to the relatively short crest length available for Cary's Lake Dam, and the large design discharge capacity required for the available reservoir head, replacement of the embankment section with a concrete overflow structure is proposed to increased spillway capacity. The existing concrete auxiliary spillways on both abutments would be repaired as required, with repairs including injection grouting at the foundation. The preliminary construction cost estimate for Cary's Lake Dam is \$1.25 million. Spring Lake Dam would receive a flatter downstream embankment slope of 4H:1V, with a turf reinforcement mat for overtopping protection, and concrete auxiliary spillway repairs for an estimated construction cost of \$350,000 (Creed, 2016).

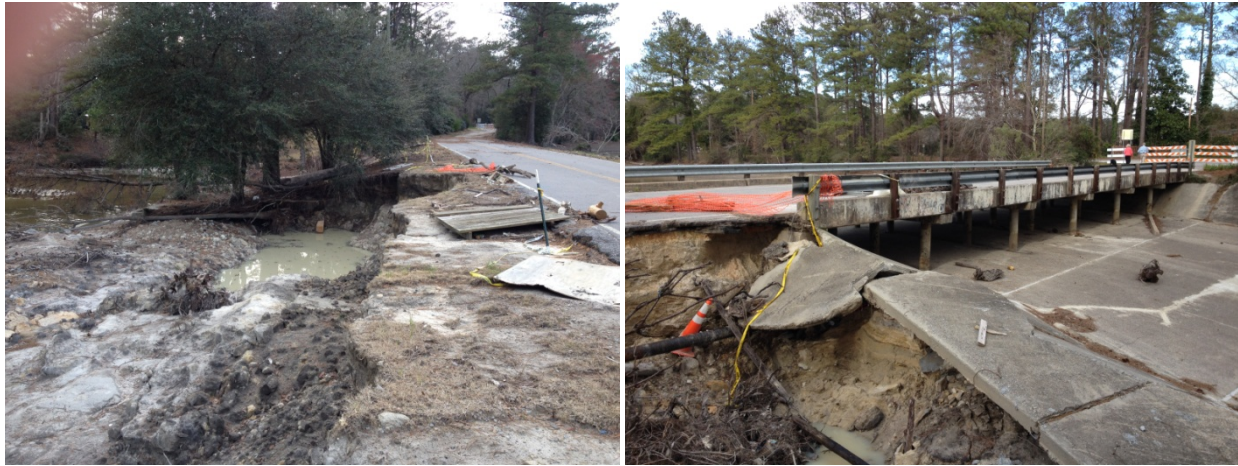
This high-hazard dam sustained significant damage to the embankment and concrete auxiliary spillway due to overtopping by an estimated 4 feet (see Figure 6). The overtopping failure of Cary's Lake Dam may have increased the peak flood levels downstream due to the breach of the upstream impoundment. The right sidewall of the auxiliary spillway washed out, allowing significant erosion of the adjoining embankment. Several concrete chute floor slabs were also washed away, exposing the structure foundation. Overtopping flows resulted in significant headcutting erosion and scour of an approximately 100-foot-long section of the downstream embankment slope, extending to the dam crest in several locations. Representative samples of the embankment soils were classified as a clayey sand with silt (SC-SM), which may have provided some erosion resistance (Tabrizi, 2016). Although undesirable from a dam safety perspective, several large trees growing on the downstream slope may have influenced flow velocities somewhat and the tree roots may have resisted embankment erosion. High tailwater from Forest Lake immediately downstream could have also reduced the overtopping damage to the embankment. The HEC-HMS model developed by HDR indicates the 10-year/24-hour storm could result in a peak reservoir water level within one foot of the Spring

Lake Dam crest, suggesting a potential for the embankment to again overtop for relatively frequent flood events. Under the current damaged conditions, the overall concern for this site for future flood events is considered to be high due to the potential for further erosion and failure of the embankment at the auxiliary spillway (HDR, 2016). Preliminary repair estimates approach \$0.5 million.

Figure 6. Extensive headcutting erosion and scour damage at the downstream slope of Spring Lake Dam (A) and at the right sidewall of the auxiliary spillway (B). Photos courtesy Schnabel Engineering.

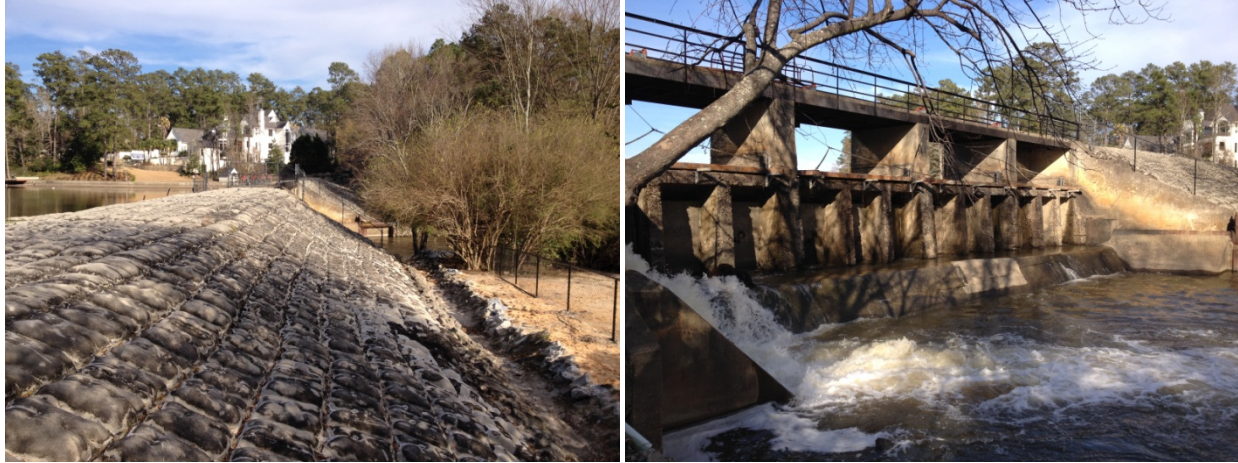
This high-hazard dam performed very well during an estimated 3 feet of overtopping (see Figure 7), and is considered to be of low concern for future flood events (HDR, 2016). Large riprap was placed in scoured portions of the approach and outlet channels for the concrete auxiliary spillway following the flood to provide additional erosion protection. The dam overtopping breach flow from Cary's Lake Dam was safely passed over Forest Lake Dam, which is located below the confluence of Jackson and Gills Creeks. The upstream failures of Upper (North) Rocky Ford Lake (or Overcreek Road) Dam and Lower Rocky Ford Lake Dam on Gills Creek, with maximum heights of 11 and 20 feet respectively, occurred the day after the failure of Cary's Lake Dam, and did not contribute to the maximum flood levels recorded at Forest Lake Dam due to their relatively small storage volumes. The earth-lined auxiliary spillways at these two upstream dams were breached during flood releases, without dam overtopping.

Figure 7. Fabric-formed concrete overtopping protection (A) and gated spillway structure (B) for Forest Lake Dam (photos courtesy Schnabel Engineering)

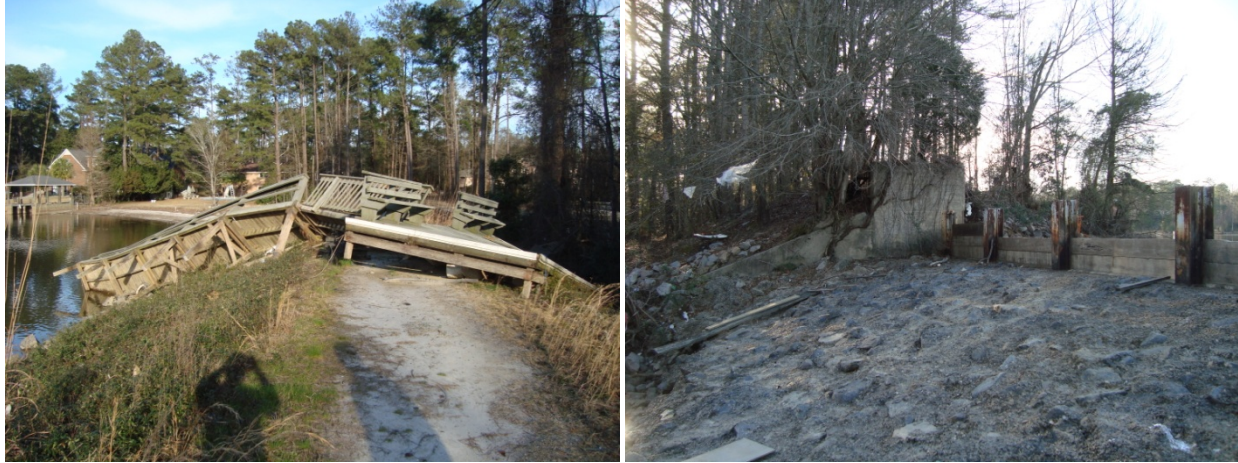
This high-hazard dam performed satisfactorily during an estimated 4 feet of overtopping, with only minor erosion (see Figure 8), and is considered to be of low concern for future flood events (HDR, 2016). Overtopping performance of the earthen dam was apparently greatly improved by very high tailwater (approaching the level of the dam crest) from Wildcat Creek, which extends near the downstream toe along much of the left embankment section and enters Gills Creek below the grouted riprap overflow crest spillway. The 22-foot-high Semmes Lake Dam on Wildcat Creek (within Fort Jackson) failed early Sunday morning, sending breach flows downstream at about the same time that Lake Katherine Dam was overtopping. Overtopping performance of the right embankment section may have been improved by the presence of several large trees on the crest and slopes (although generally undesirable), which could have reduced flow velocities and provided some degree of erosion protection. The left abutment auxiliary spillway is grass-lined with a jute mat and experienced minor to moderate erosion (up to a reported 2 feet), probably also benefitting from the high tailwater from Wildcat Creek. Representative samples of the embankment soils were classified as a poorly graded sand (SP), which would not have provided much erosion resistance (Tabrizi, 2016).

Figure 8. Debris deposited on crest of left embankment during overtopping (A) and heavily wooded right embankment beyond overflow spillway crest (B) at Lake Katherine Dam (photos courtesy Schnabel Engineering).

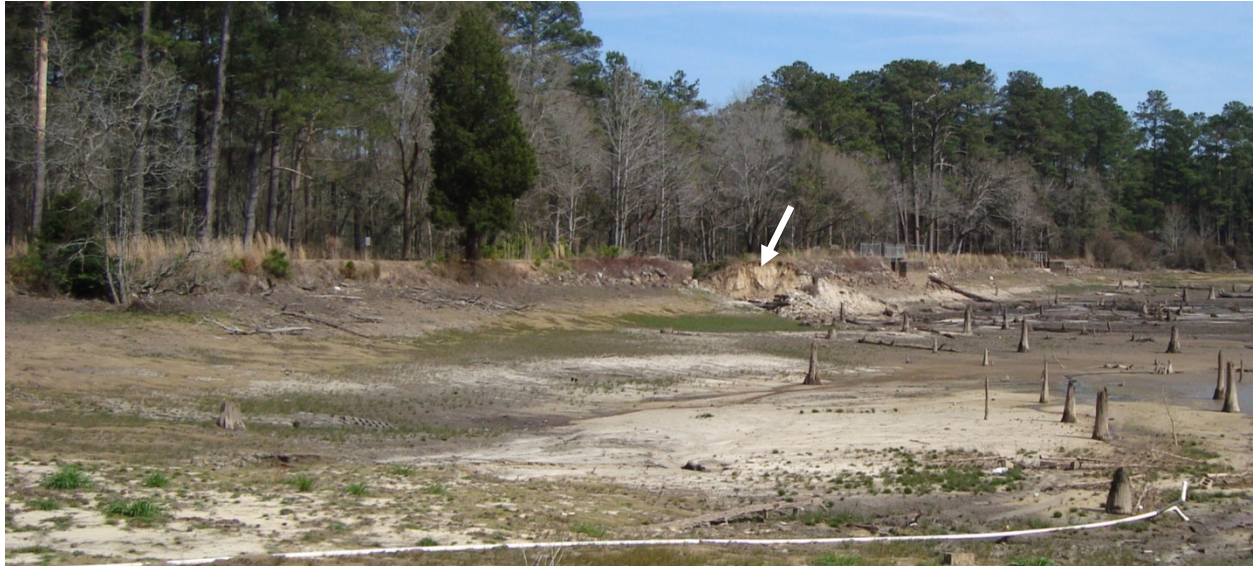
Barr Lake Dam was privately-owned and the centerpiece of a new housing development with more than 300 proposed home sites. It was classified by DHEC as a significant hazard dam and was breached by the October flood (see Figure 9). The breach width was approximately 60 feet at the dam crest and 30 feet at the foundation, based on a topographic survey of the site following dam failure. Failure appears to have occurred due to piping at the location of an abandoned concrete conduit to the left of the center-most concrete spillway. Although the auxiliary spillways both operated, the dam did not appear to have been overtopped. A numerical hydraulic model of the dam developed by Schnabel Engineering indicated dam overtopping of approximately 0.6 feet during a rainfall event of the magnitude experienced during the October flood. It is believed that the localized dam breach occurred prior to the peak inflow, thus preventing dam overtopping. Both auxiliary spillways were also noted in the model to operate for floods as small as the 2-year flood event. Representative samples of the embankment soils were classified as a clayey sand with silt (SC-SM), which may have provided some erosion resistance (Tabrizi, 2016).

Figure 9. Embankment breach at center of photo (at arrow), with two concrete spillways visible to right and approach channel to left abutment auxiliary spillway visible in the foreground, at Barr Lake Dam (photo courtesy Schnabel Engineering)

Preliminary hydrologic and hydraulic analyses performed by Schnabel Engineering indicate that if the embankment dam breach was to be simply repaired, the existing dam crest would be overtopped by 0.4 feet during the 100-year flood, and by 1.9 feet during the ½ PMF, based on the total available spillway discharge capacity (Schnabel 2016). Possible remediation measures to meet regulatory requirements include raising the embankment dam crest, lowering the normal operating pool, increasing the total spillway discharge capacity, and providing overtopping protection. Additionally, due to the erodible nature of earthen channel spillways, the auxiliary spillways should either be armored or raised to limit operation to floods greater than the 50-year event.

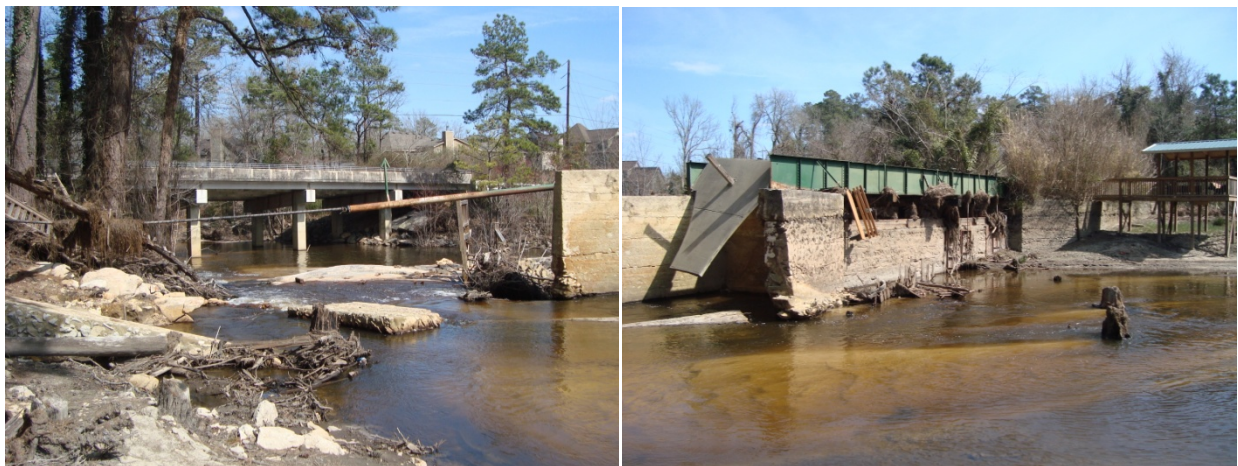
Figure 10. Breach of Gibson Pond Dam embankment (A) and remaining concrete gravity overflow section (B). Photos courtesy Schnabel Engineering.

Schnabel Engineering recently completed hydrologic and hydraulic analyses of Gibson Pond Dam for the City of Lexington (Schnabel, 2015). This includes the analysis of the watershed and the spillway discharge capacity prior to failure of the dam, determination of precipitation amounts and areal distributions for the various storm events utilized in the analysis, and development of a HEC-HMS model to route storm runoff through the existing reservoir and dam. Based on these analyses, the dam in the configuration prior to failure was incapable of passing and/or storing runoff associated with the DHEC design storm, which for this site is the ½ PMF event. Based upon discussions with DHEC representatives, the dam will likely be re-classified as a Category I, or High Hazard, due to the potential failure of downstream structures, such as Old Mill Dam, should the subject dam fail. Evaluations of rehabilitation alternatives are currently underway, including overtopping protection, in order to increase the hydraulic capacity of Gibson Pond Dam to meet regulatory requirements.

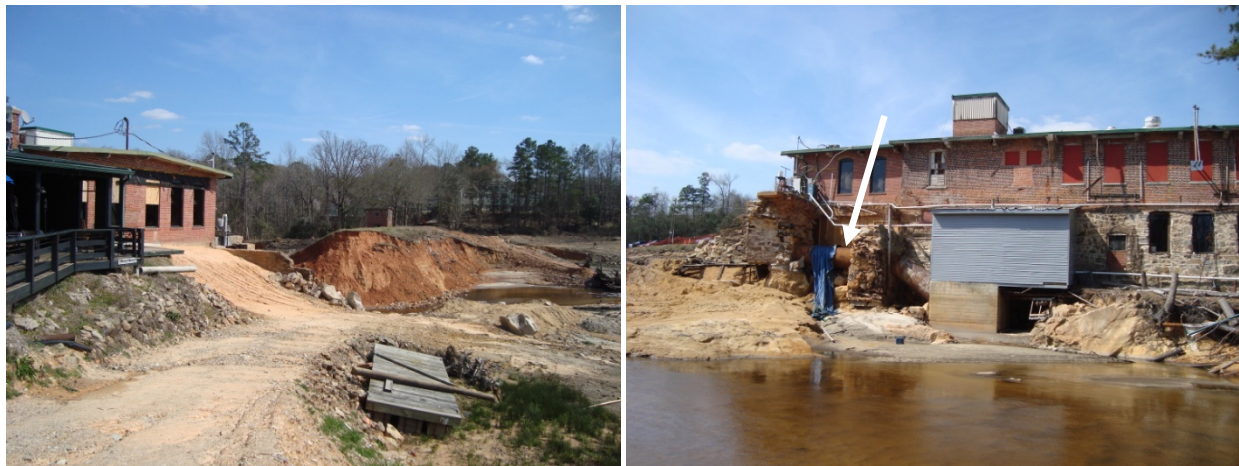
Breach flows from Barr Lake and Gibson Pond Dams caused overtopping and failure of the dam embankment (see Figure 11). The breach extended from the left abutment structure, fully exposing the penstock, and measured 104 feet at the dam crest and 82 feet at the foundation. Representative samples of the embankment soils were classified as a clayey sand with silt (SC-SM) (Tabrizi, 2016). Repairs to restore the impoundment are estimated to cost up to \$5 million.

Figure 11. Breach of Old Mill Dam embankment near left abutment (A) and exposed penstock (see arrow) (B). Photos courtesy Schnabel Engineering.
